Place a 60' piece of new 50 pair copper cable to replace a bad section of copper cable.

CenturyLink Maintenance Job
Engineer: Shawn Niess
Office: 651-312-5389

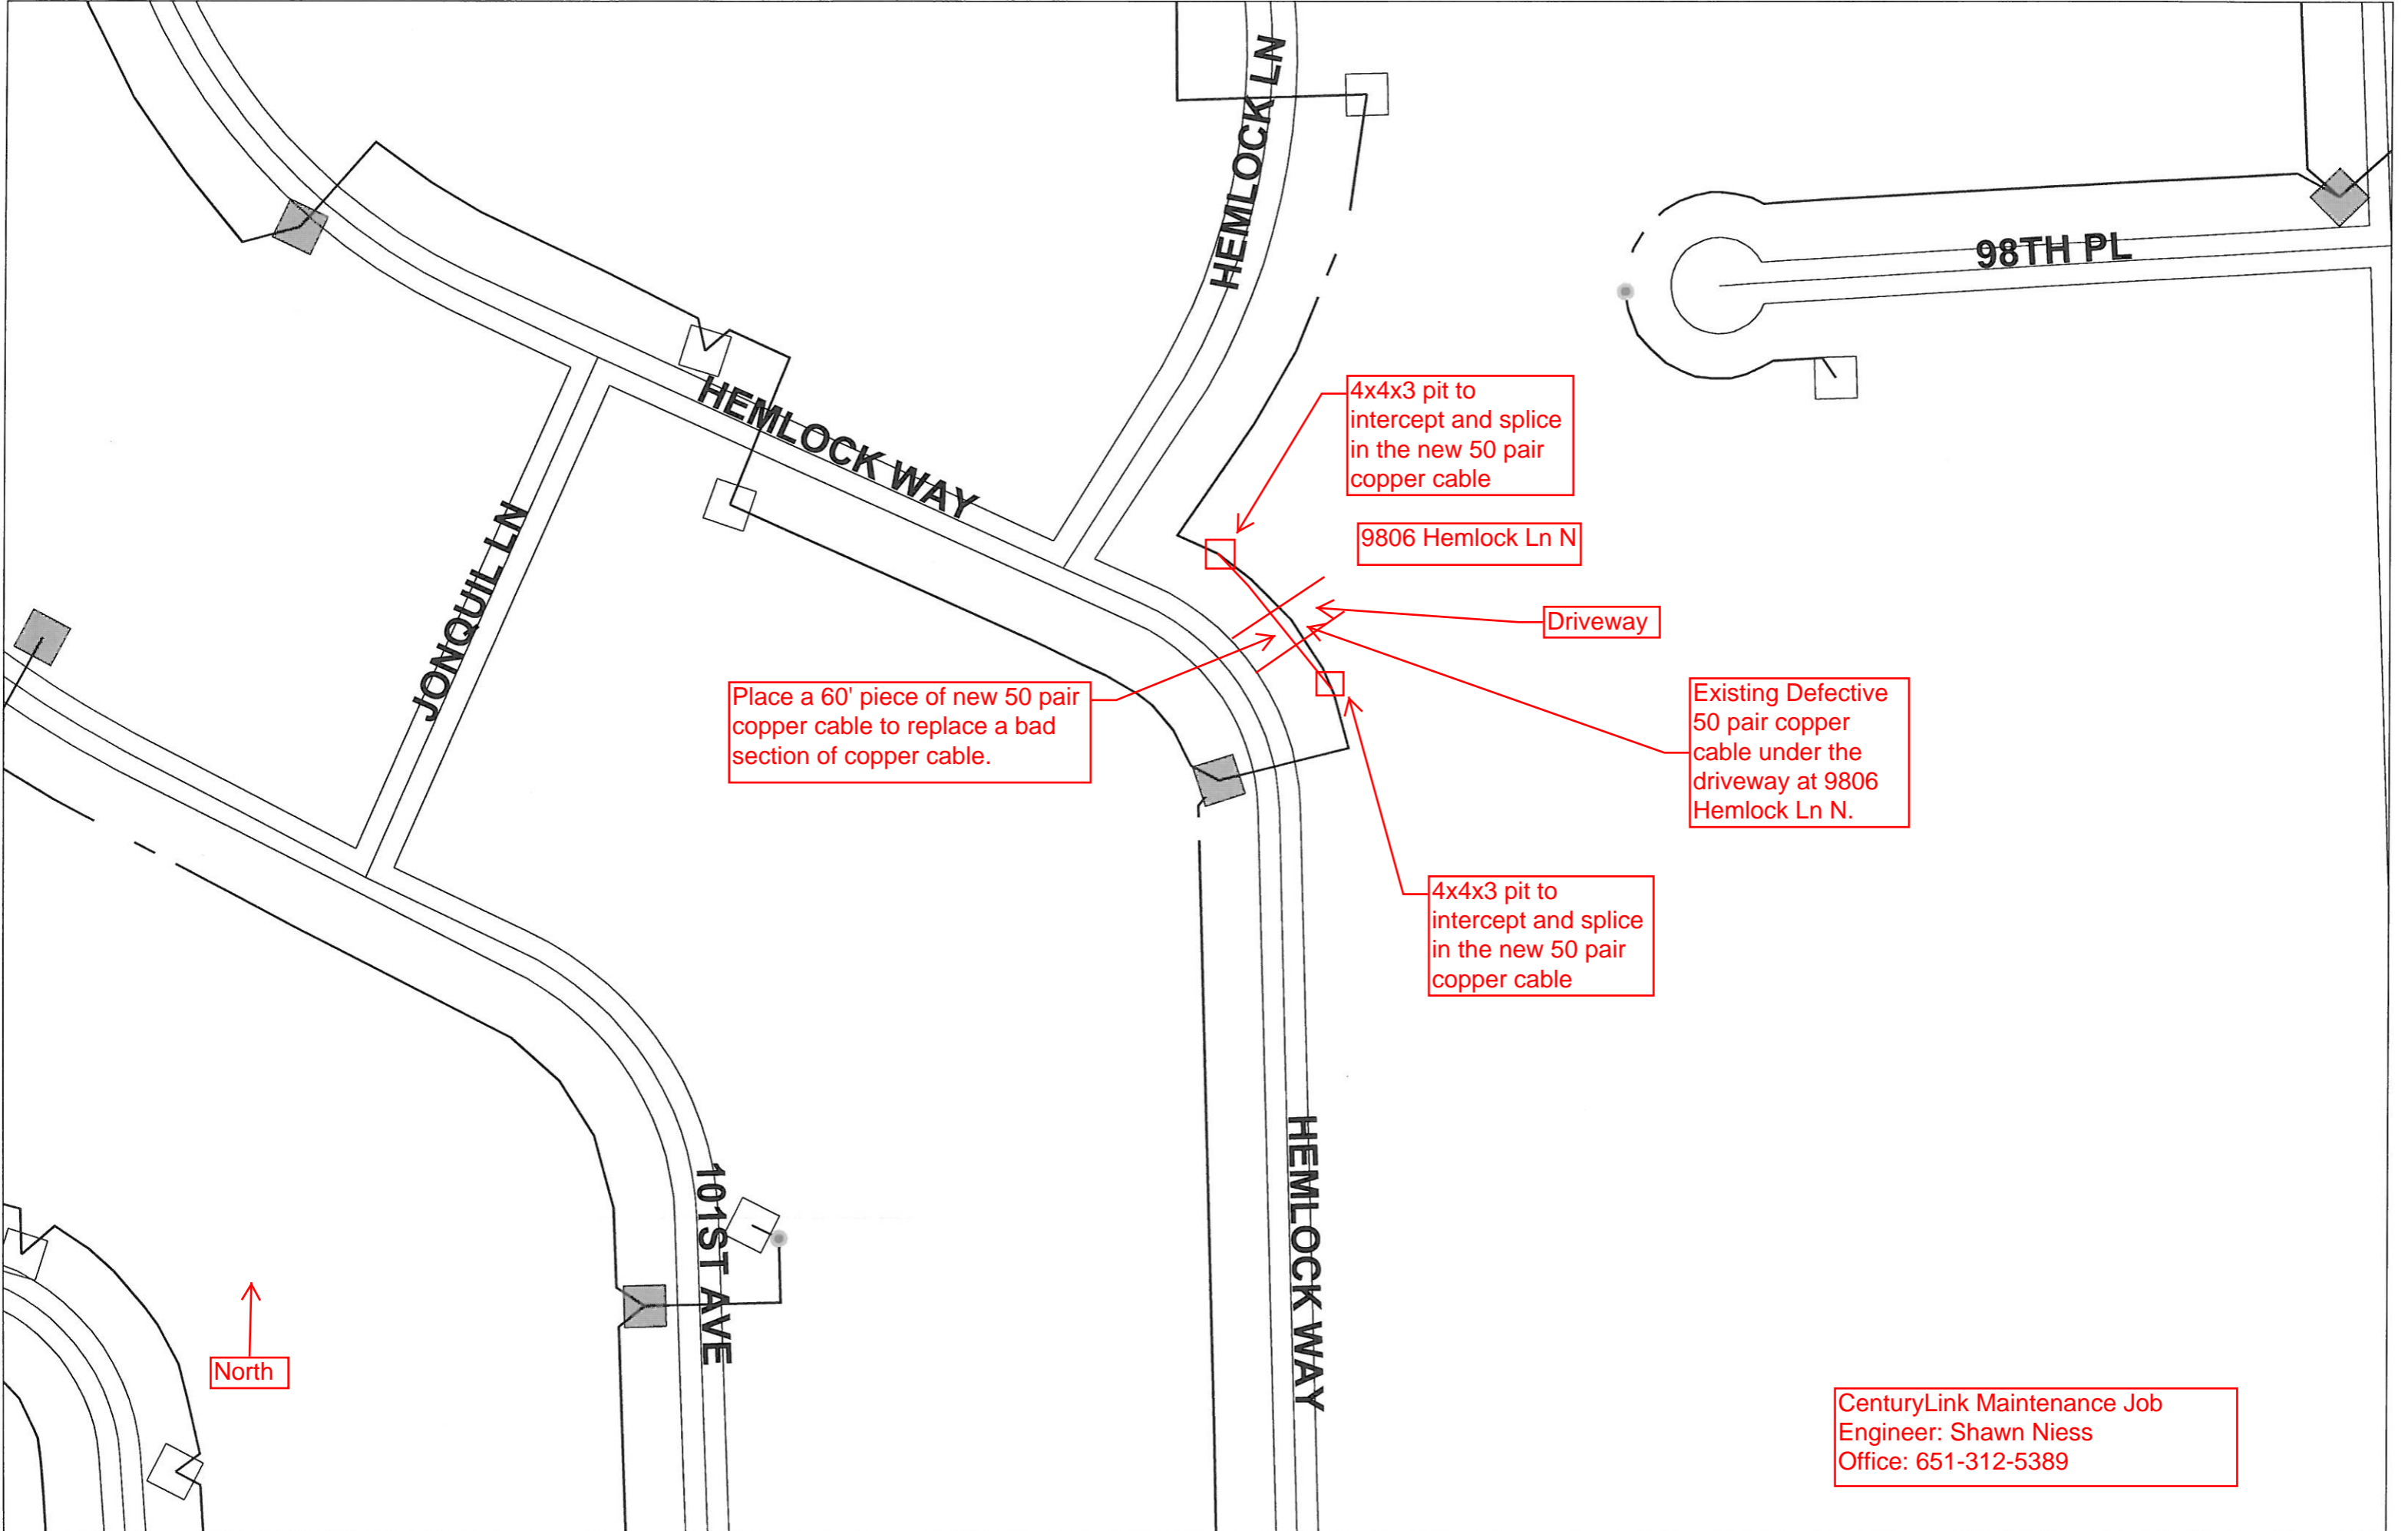
Existing Defective 50 pair copper cable under the driveway at 9806 Hemlock Ln N.

4x4x3 pit to intercept and splice in the new 50 pair copper cable
