CenturyLink BSW Order/Maintenance Work Authorization

Company	Exchange Name	OSSEMNXO	Service Order#	
Work Activity	Fiber-Buried	Capital	N	Maintenance
Customer Name	JENNIFER HALVORSON	Phone#	(763) 425-0313	
Address	10530 NATHAN LN N	One Call Ticket#		
City & Zip	MAPLE GROVE, MN 55369-2757			
Location/Directions	GPS			
Description of Work or Special Instructions	see sketch for details. CURRENT DROP AT LOCATION IS BAD TO MST. POSSIBULE DIG AND FIX IN THE SPRING

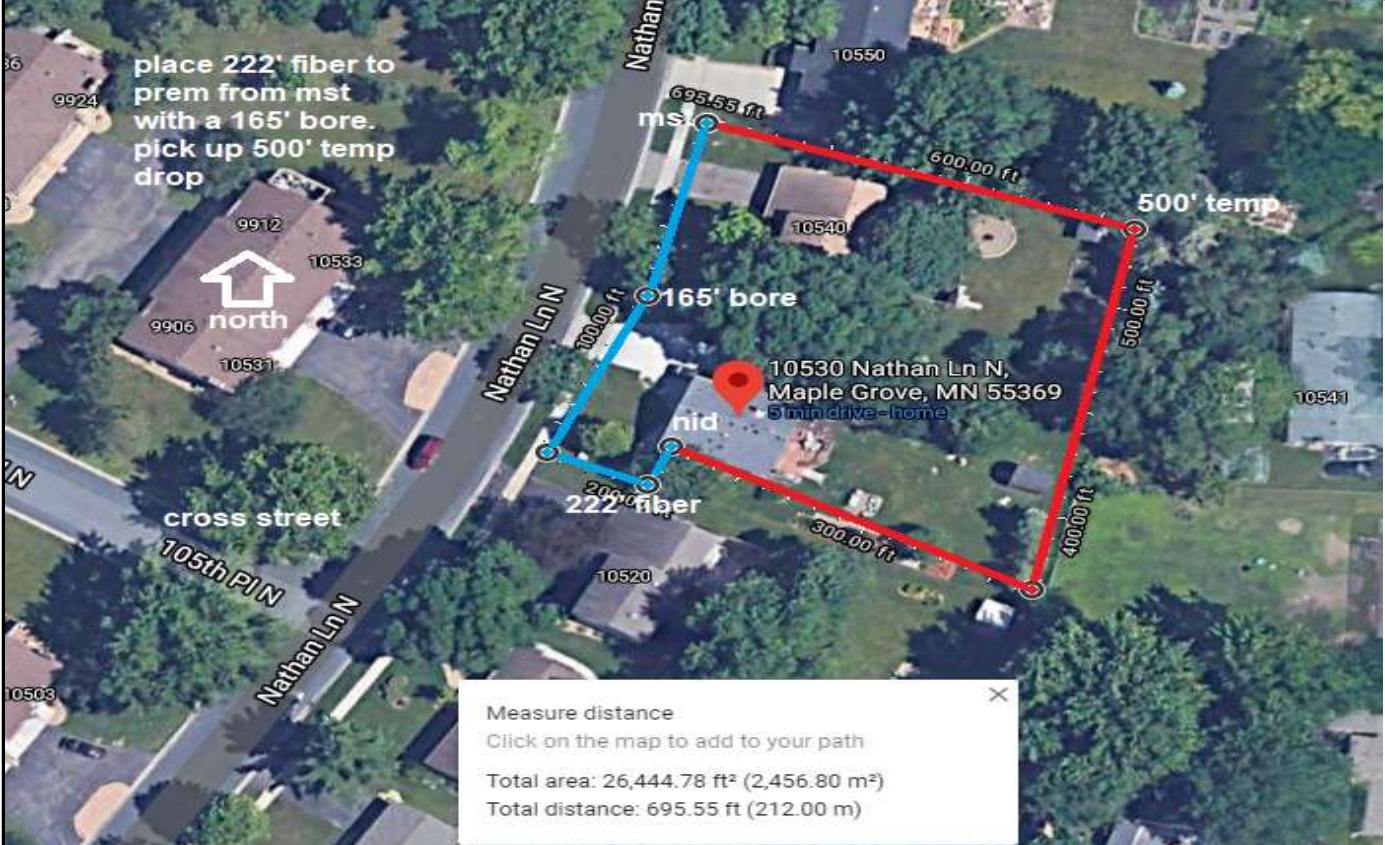
AND FIX IN THE SPRING
