Overview

Replacing damaged span of cable on behalf of Comcast.

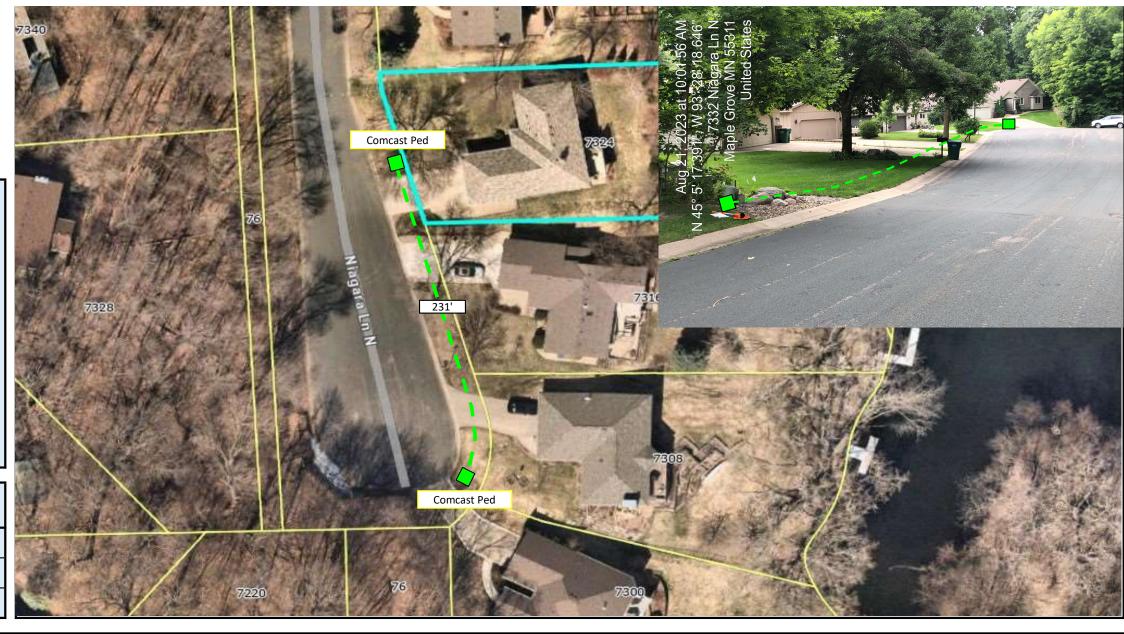
Directional boring approximately 231' on ROW from

Comcast Ped located infront of 7324 Niagara Ln N, south to

Comcast ped located at 7300 Niagara Ln N. Potholing where
necessary to identify existing utilities.

Method: 2" directional bore (231')

Conduit: 2" PVC conduit Cable: .625 coaxial cable
